Fast Fix Airbag Clockspring Replacement

The clockspring is a plastic circuit in a vehicle's steering mechanism that connects the steering column to the steering wheel without breaking the electrical connection when it rotates.

When the clockspring fails, the steering wheel loses its electrical connection, and its buttons, horn, and other features stop working. This guide will help you replace the clockspring and restore the functionality of the steering wheel buttons in a **2014 Ford F150 Lariat** pickup truck.

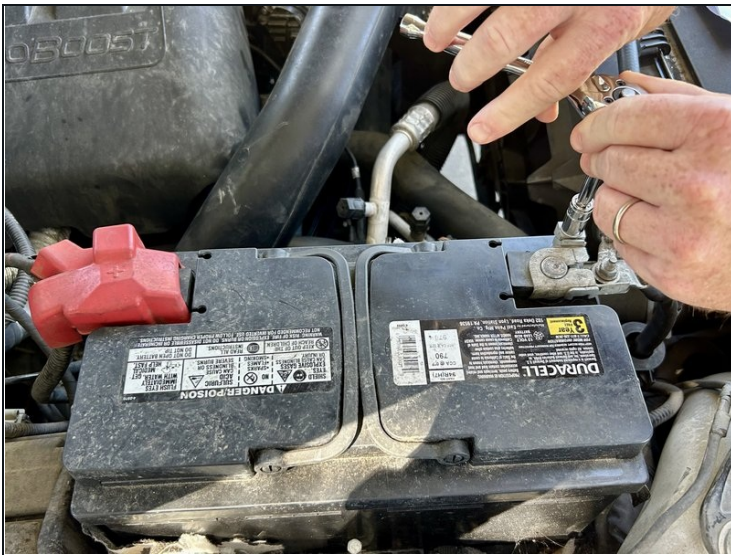
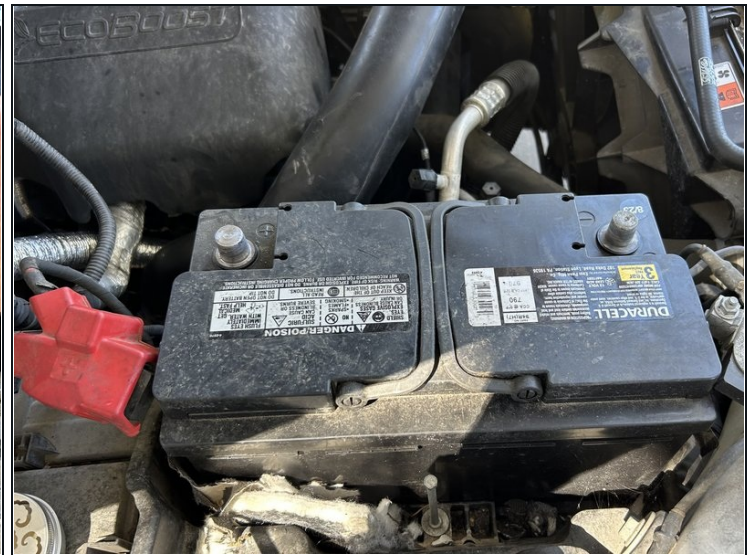
Step 1 — Airbag Clockspring

- Disconnect the cables to your vehicle battery using a socket wrench and 10mm socket.

⚠️ Wait 10-15 minutes for the capacitors to discharge to ensure that no power can trigger the airbag to deploy.

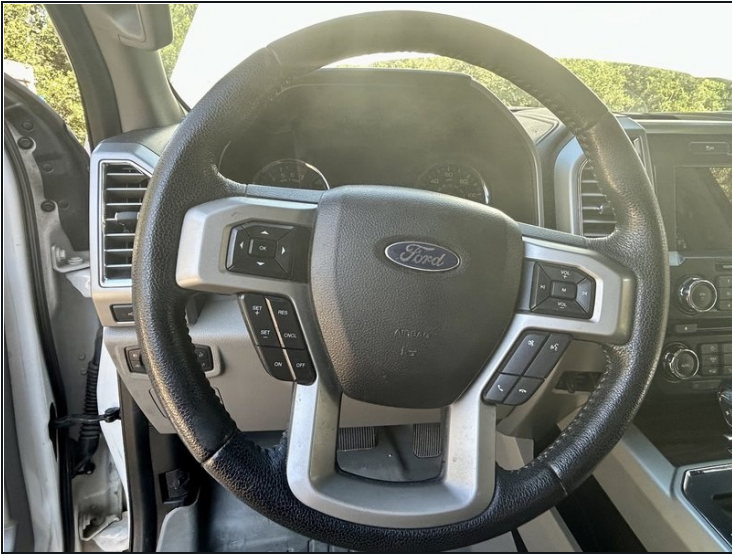
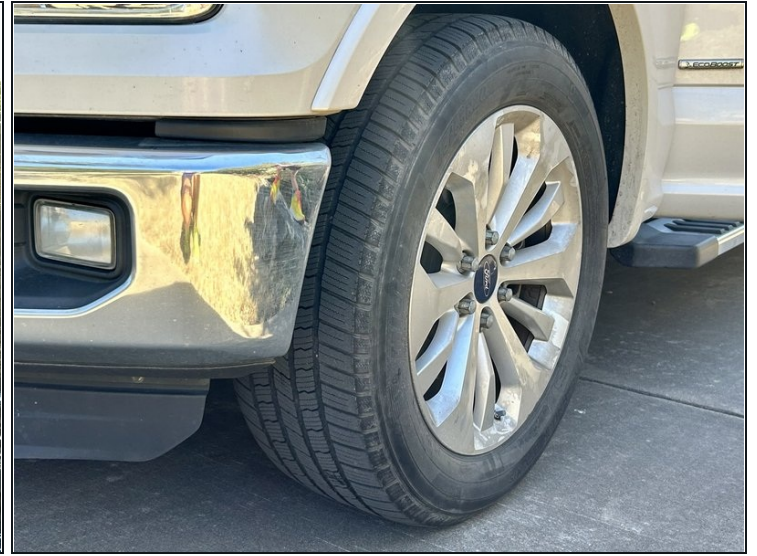
Step 2

- Make sure that your steering wheel and wheels are in the straight position.

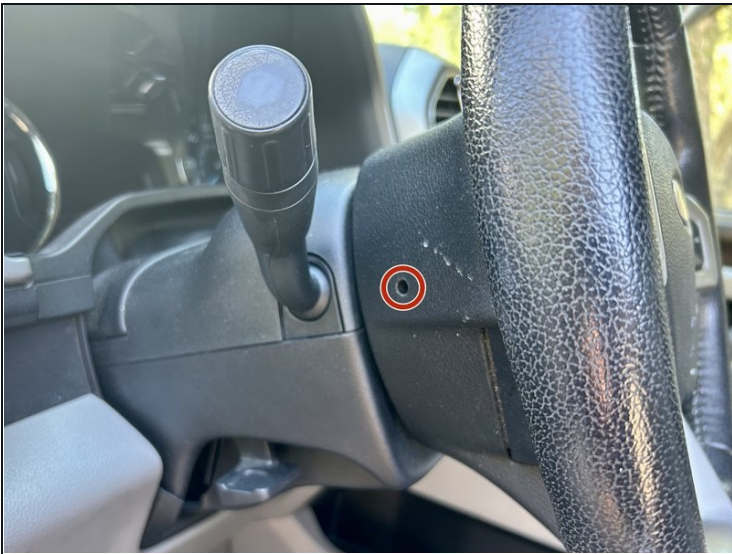
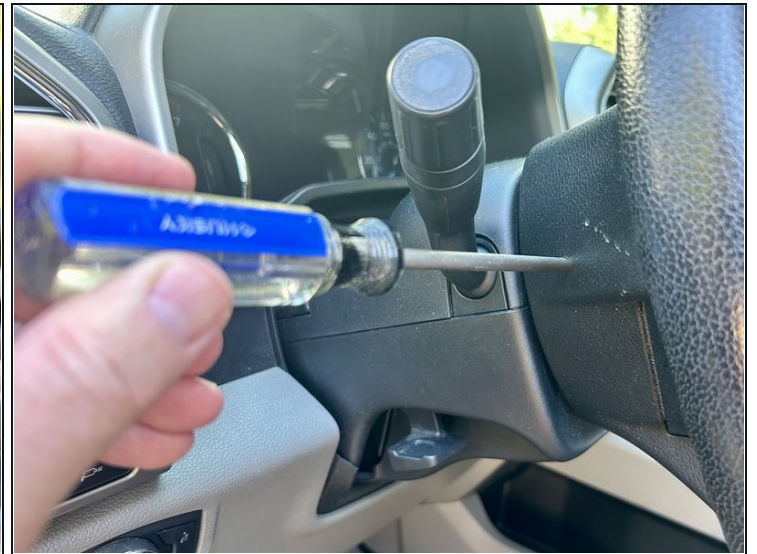
Step 3

- Find the two holes on the sides of the steering wheel.
- Insert a small screwdriver into the hole on one side and push to release the clip holding the airbag in place.
- Repeat on the opposite side to release the airbag.

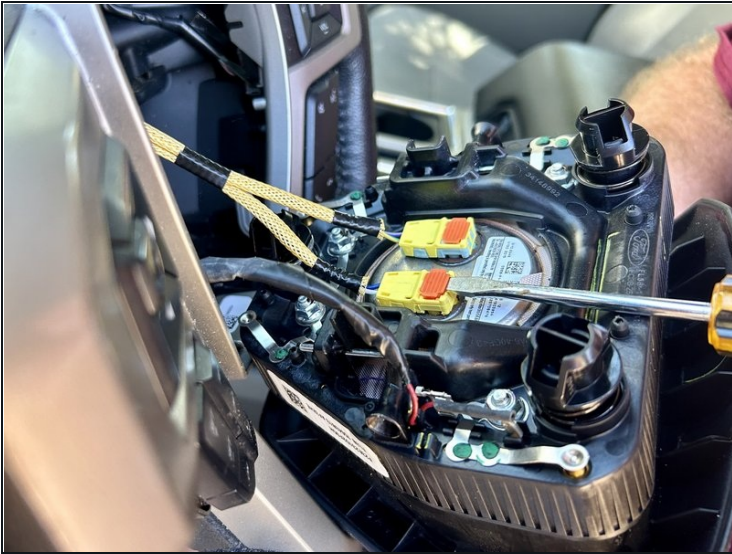
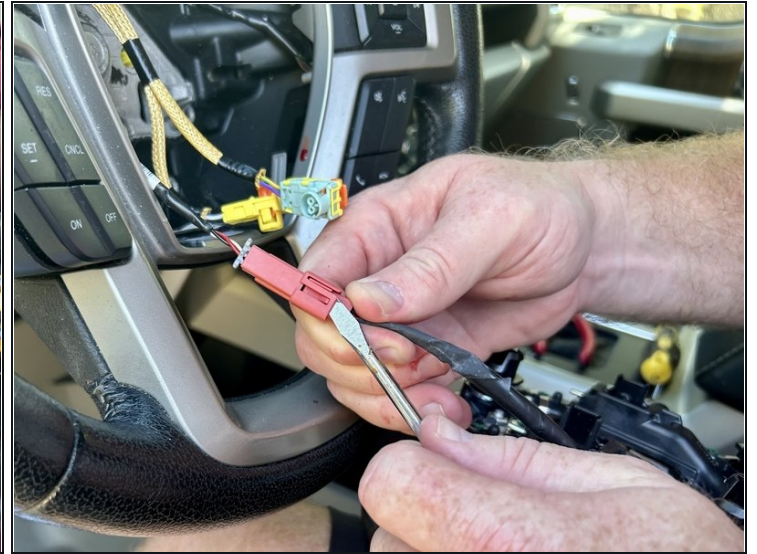
Step 4

- Use a small flathead screwdriver to pop up the tabs on the airbag connector wires and disconnect them.
- Disconnect the horn wire.
- Carefully remove the airbag and set aside.

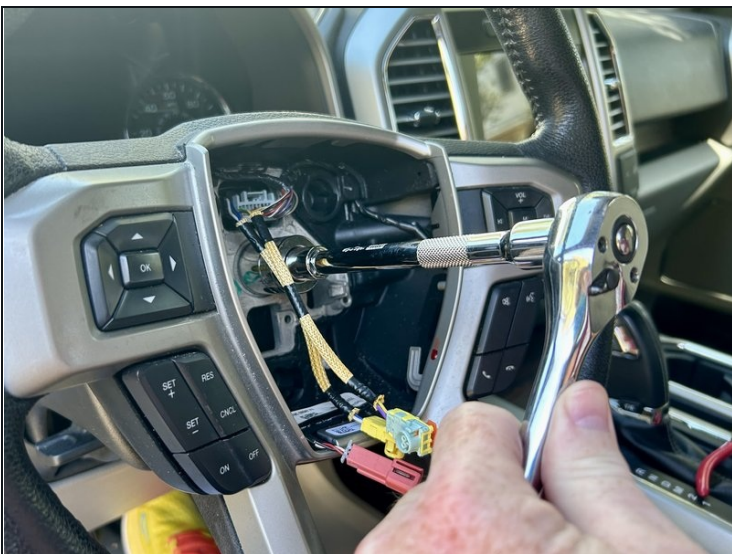
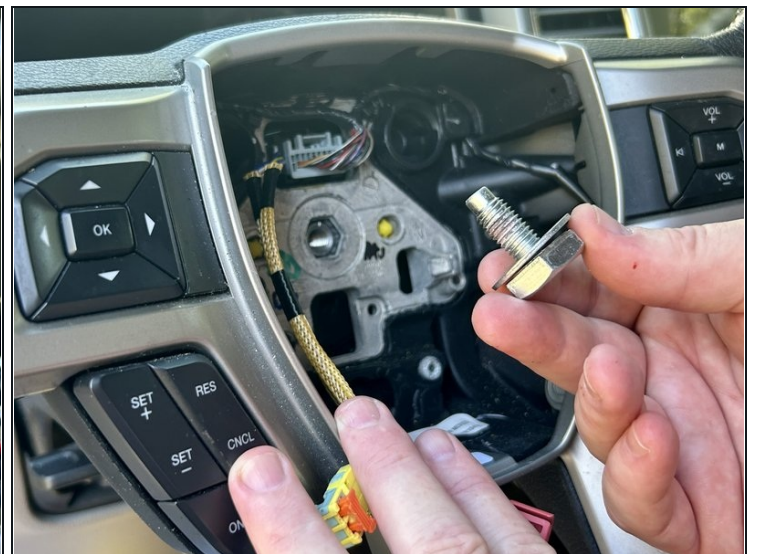
Step 5

- Use a socket wrench and 24mm socket to remove the steering wheel bolt.

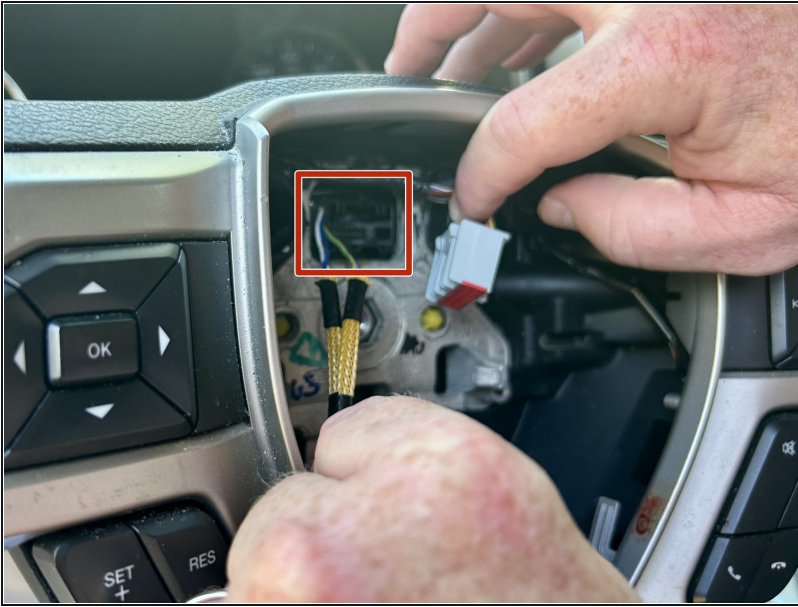
Step 6

- Unclip and disconnect the steering wheel wires at the top.

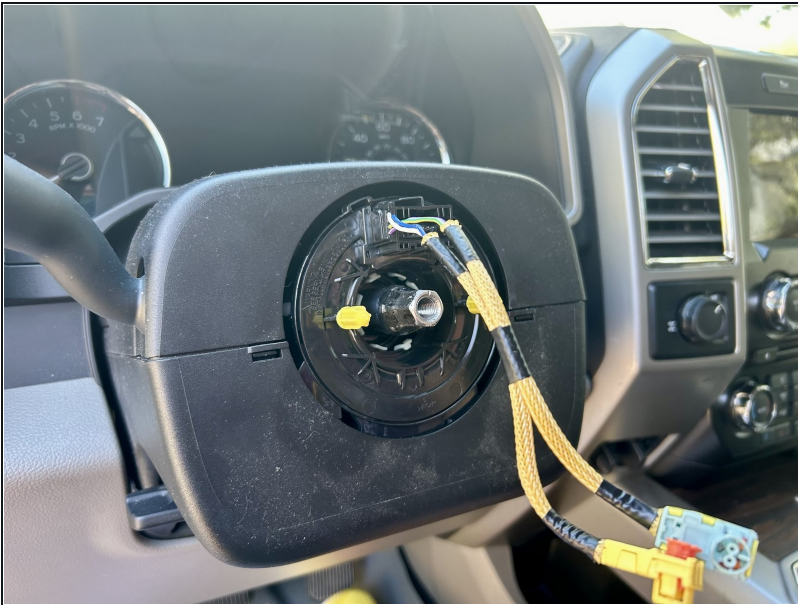
Step 7

- Pull the steering wheel away from the steering column and set aside.

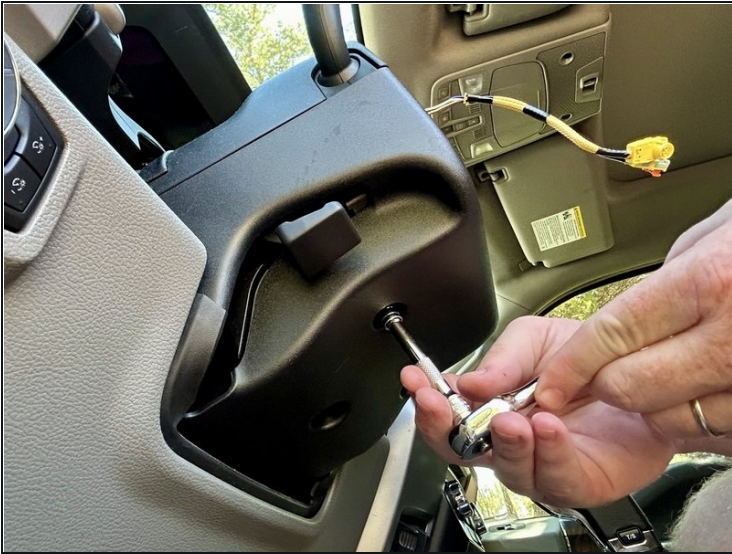
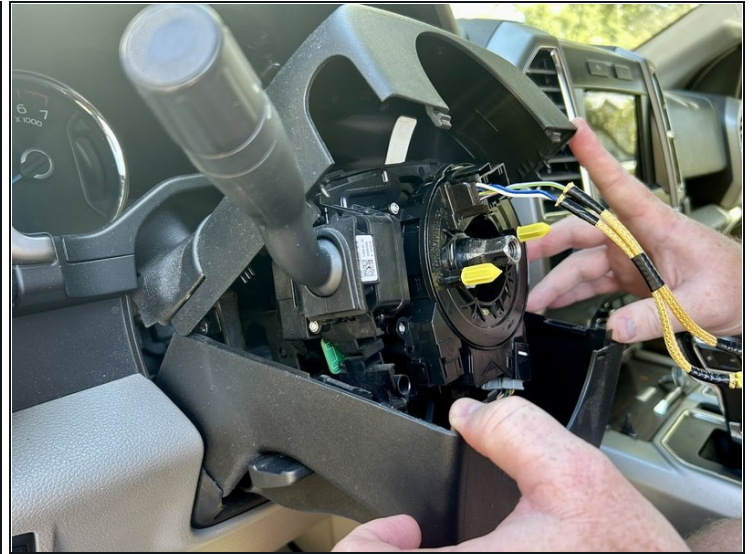
Step 8

- Use a socket wrench and 7mm socket to remove the three screws underneath the steering column that hold the two parts of the steering column covers in place.
- Separate the steering column covers and push them aside to access the clockspring.

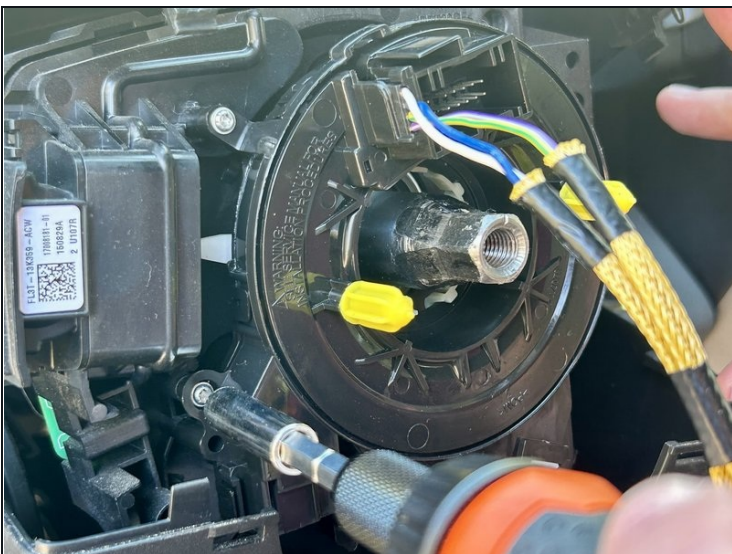
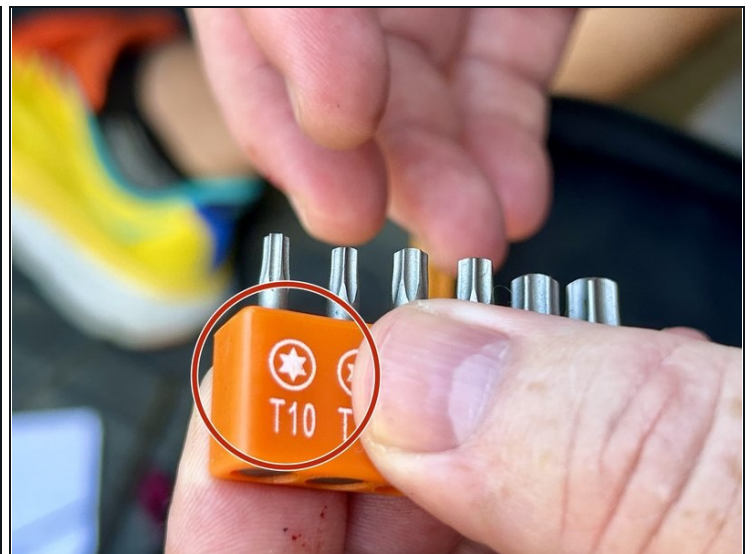
Step 9

- Unscrew the broken clockspring using a Torx screwdriver and T10 bit to remove the four screws holding it in place.

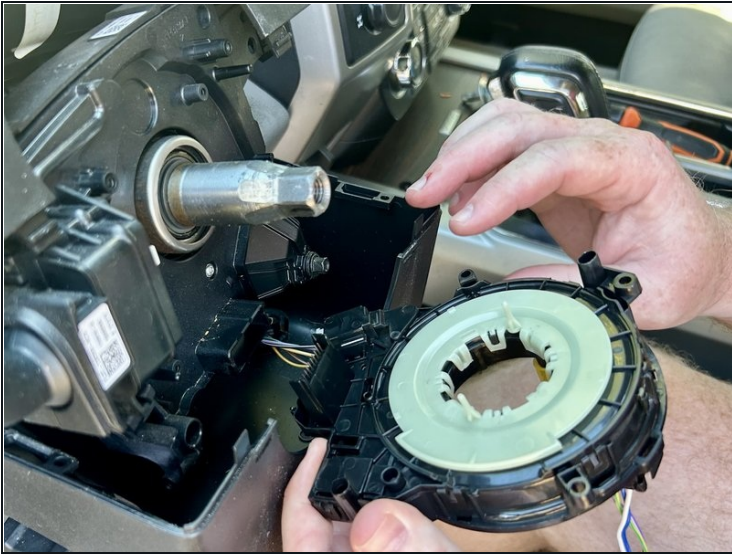
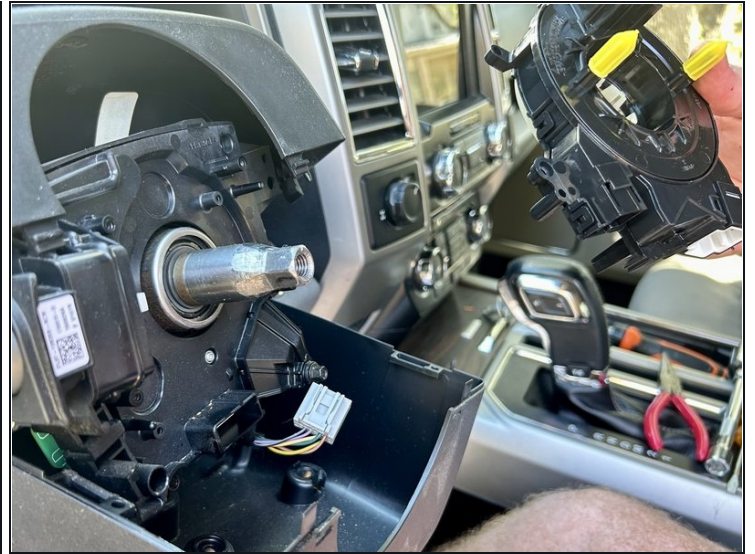
Step 10

- Remove the broken clockspring and set it aside.

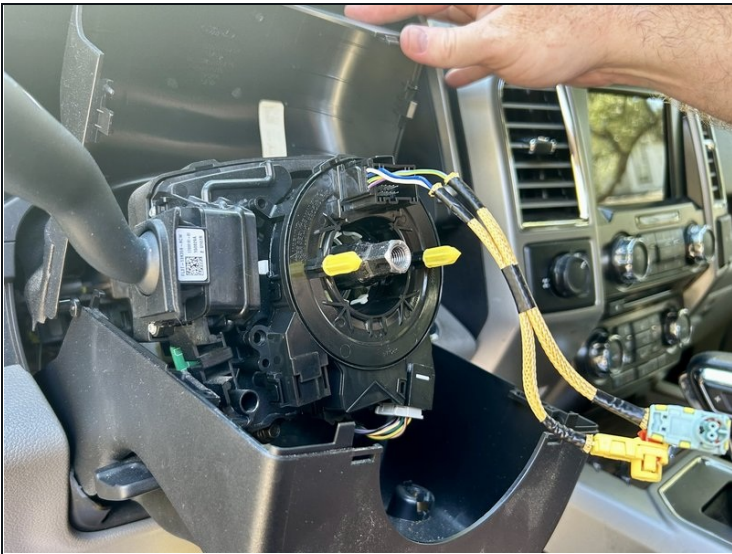
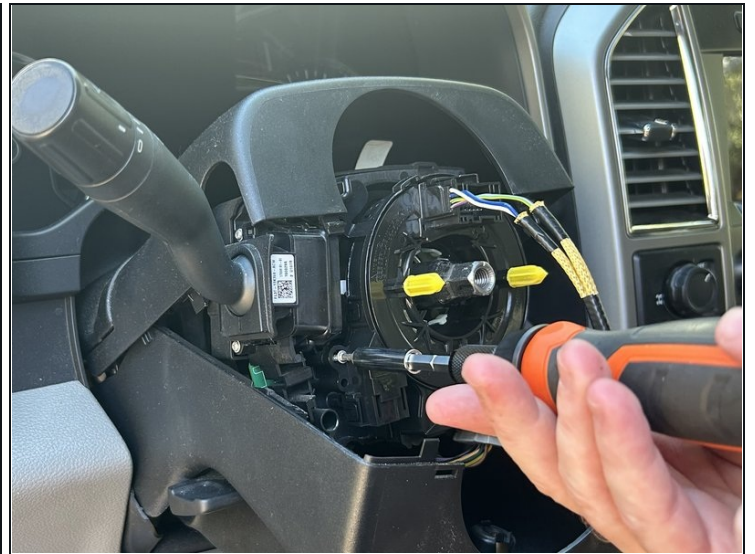
Step 11

- Install the new clockspring using a Torx screwdriver and T10 bit.
- Replace the four screws and tighten them.
- Remove the clockspring lock tab to release the new clockspring mechanism.

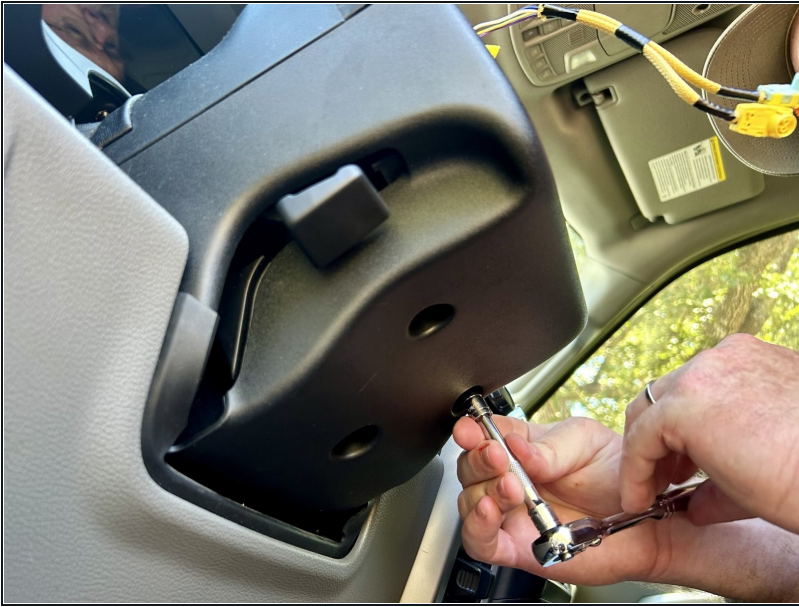
Step 12

- Move the steering column covers back into place and replace the three screws underneath using a socket wrench and 7mm socket.

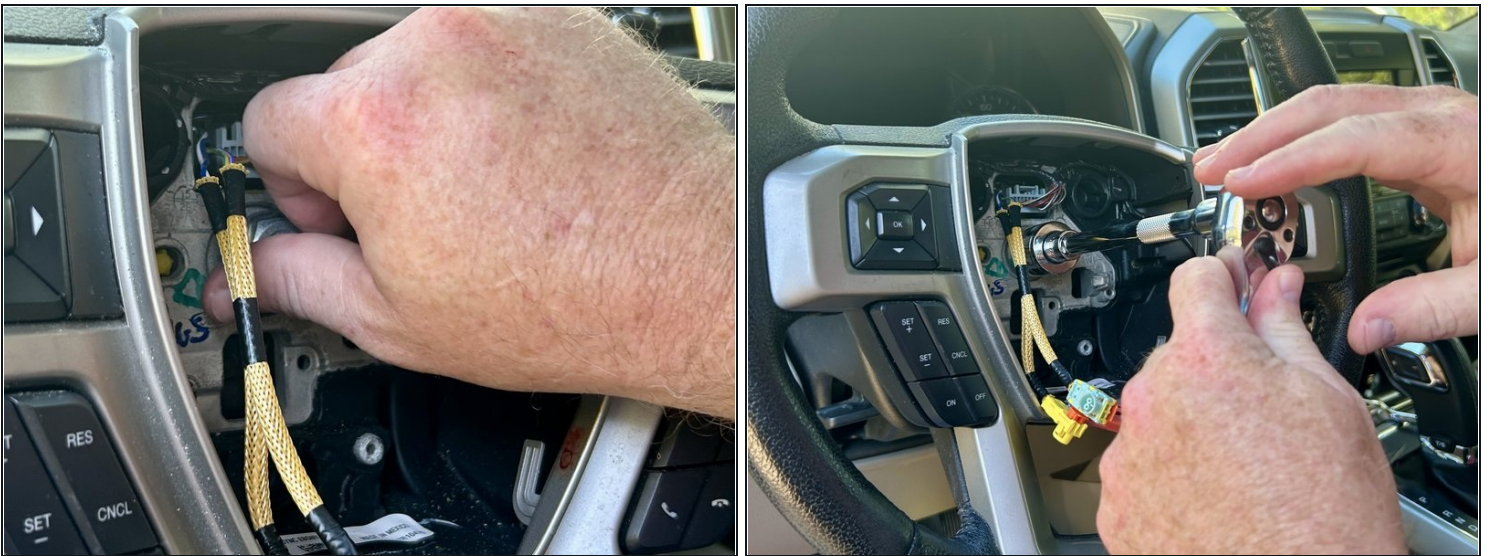
Step 13

- Feed the two airbag wires through the back of the steering wheel to begin replacing it.
- Replace the steering wheel bolt and tighten it with a socket wrench and 24mm socket.

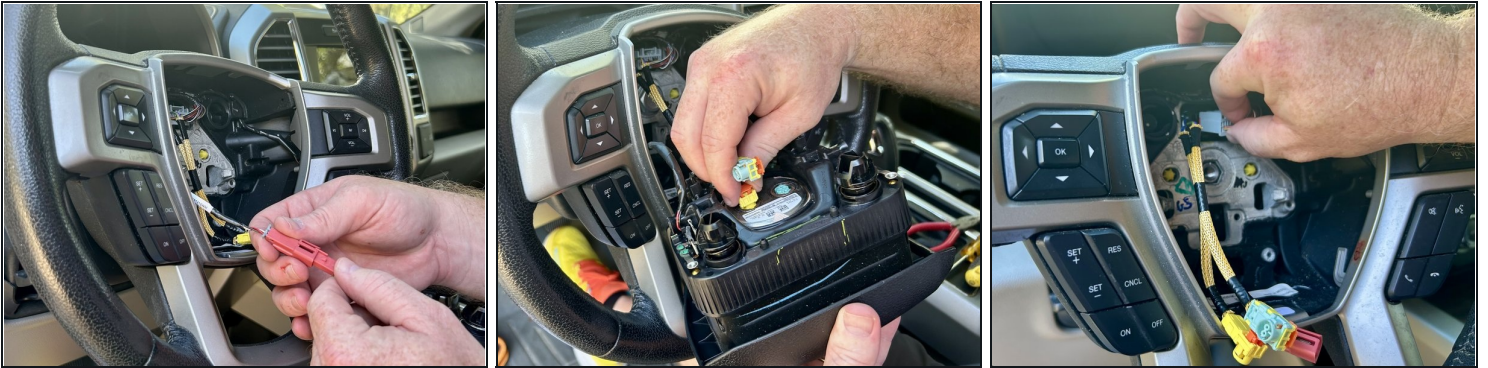
Step 14

- Reconnect the horn wires and the airbag wires.
- Push down the tabs on the airbag wire connectors to make sure the connection is good.

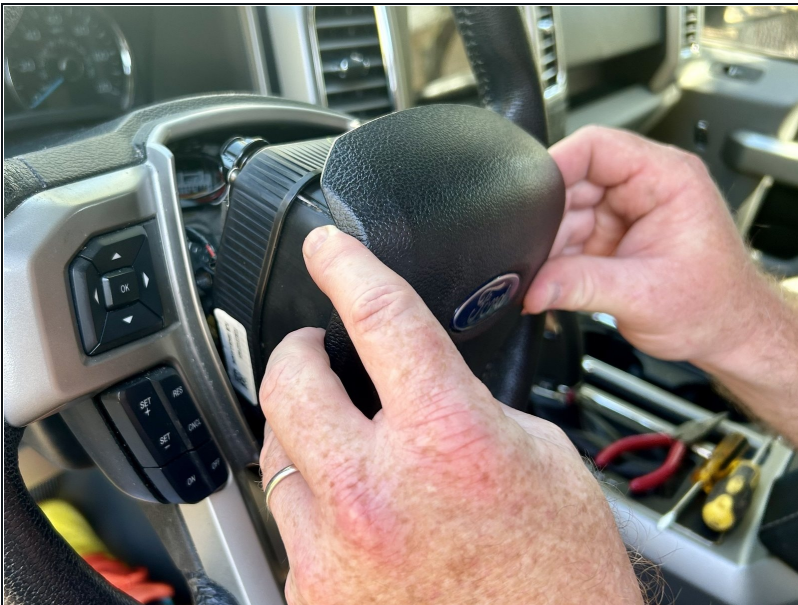
Step 15

- Return the airbag to its place and push it to clip it back in place.

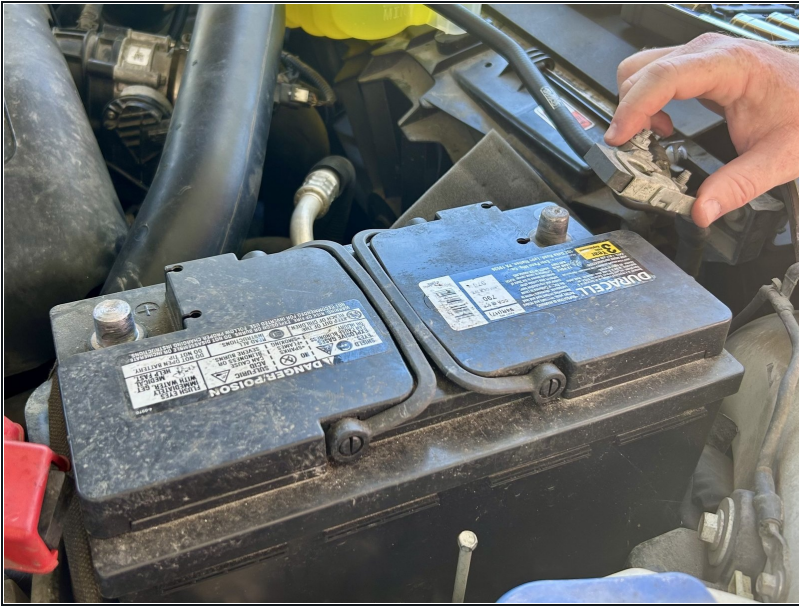
Step 16

- Reconnect the battery cables.

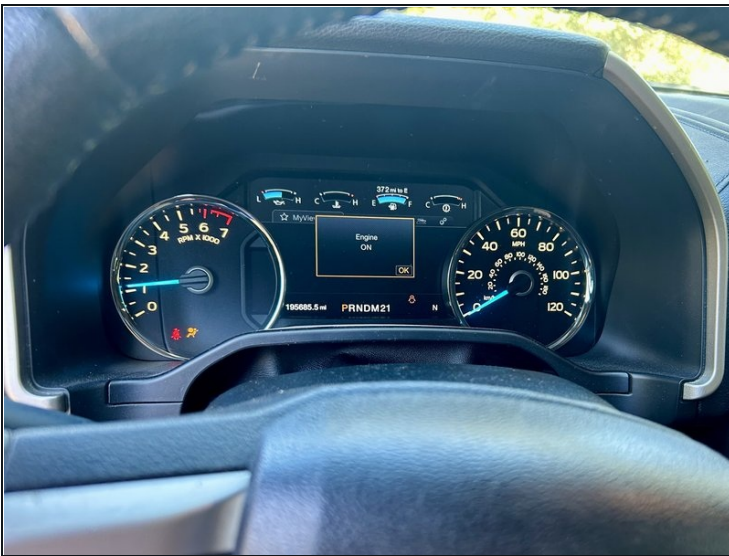
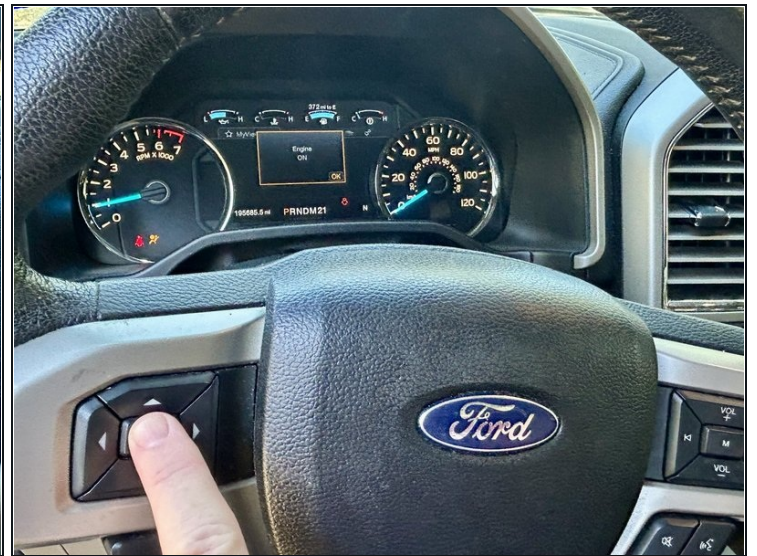
Step 17

- Check for a successful installation by cranking the vehicle to see the Engine OK light indicator on the dashboard.
- Check that the steering wheel control buttons work.
